Manhole Inspection Summary

Manhole # S43SS_025MH

Insp Date: **2/22/07 10:30 AM**

Location Address: **1649 GORSUCH AVE**

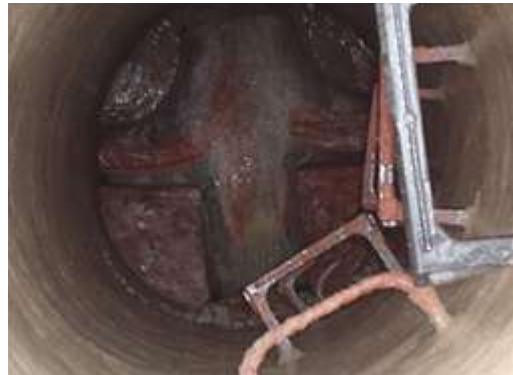
Top View

Corroded steps. Bench debris.

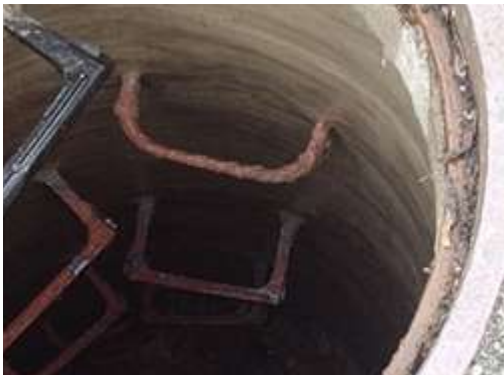
Defect

Infiltration: ☐ None ☒ **Joint** ☐ Cracks ☐ Mortar ☐ Roots ☒ **Wall**

Infiltration: ☐ None ☐ Joint ☐ Cracks ☐ Mortar ☐ Roots ☒ **Wall**

Adjustment, Corbel and Barrel infiltration.

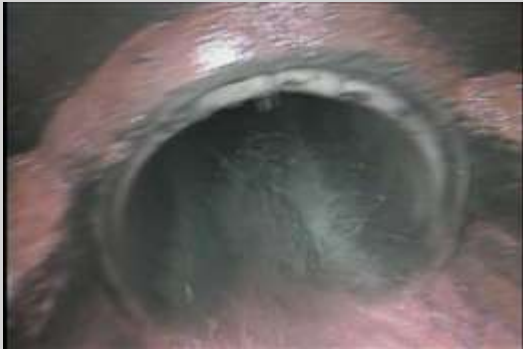
18 in. Circular Gravity Sewer Pipe Out @ 12 O'Clock

Invert Depth: **14.76** (ft.) Flow Characteristics: **Turbulent**

Infiltration: **None** Pipe Seal Cond: **Unknown**

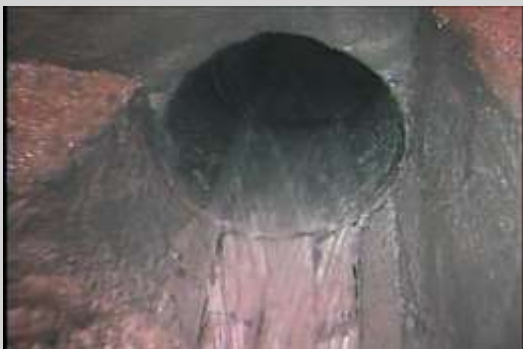
10 in. Circular Gravity Sewer Pipe In @ 3 O'Clock

Invert Depth: **14.06** (ft.) Flow Characteristics: **Fast**

Infiltration: **None** Pipe Seal Cond: **Unknown**

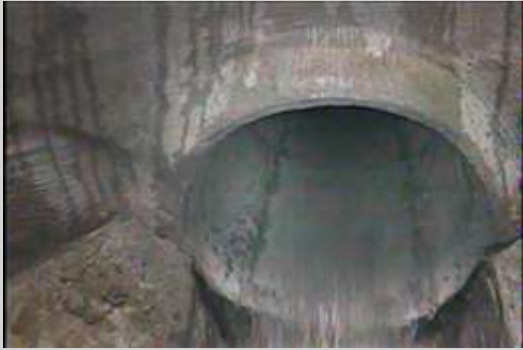
Pipe In @ 6 O'Clock

Invert Depth: **13.49** (ft.) Flow Characteristics: **Turbulent**

Infiltration: **None**

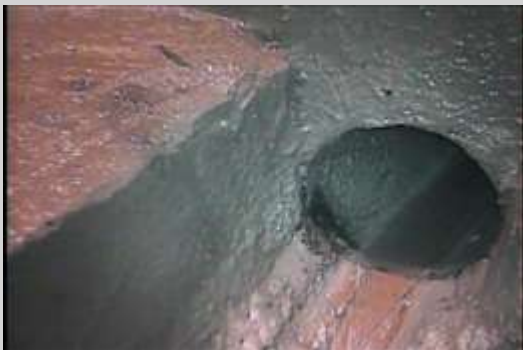
Pipe In @ 9 O'Clock

Invert Depth: **13.99** (ft.) Flow Characteristics: **Fast**

Infiltration: **None**
